## Failures in carbon fibre reinforced composite boat structures.

### Examples of carbon fibre failure.

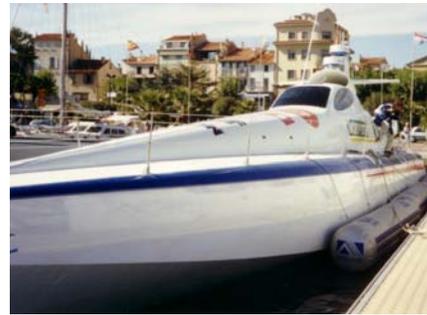
A water jet driven motor boat was mounted with its power plant inline with the gear box, two out board impellers and a fixed stator ring. The impellers were contra-rotating in order to reduce the rotation of the flow, and were arranged so that flow first passes through the left hand blades then the right in order to simplify the gearing and hence minimise gear box mass. The power plant and transmission were mounted to the hull on girders. The designers of the boat had intended that the gear box input and output shafts should both rotate clockwise, as built the gearbox shaft ran anticlockwise, resulting in a torque across the gear box far in excess of that in the design case. This resulted in over stressing of the hull beneath the gear box leading to crack initiation and propagation. The boat and all hands were rescued but the vessel broke in two on the shore.

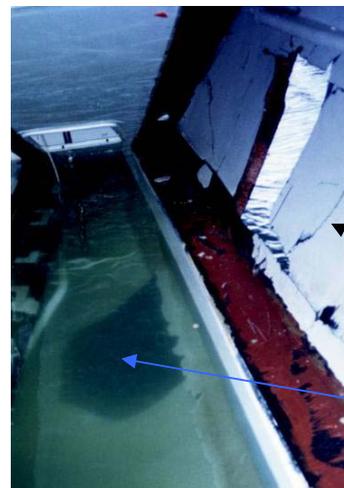
View of holed hull from yacht interior

Cracking of the laminate skins seen where the gel coat has fractured

Hole visible below the water

Examinations of the skin laminates and the aramid honeycomb coring showed that there were no problems arising from manufacture and the skin thicknesses were compliant with standards. The yacht had a very shallow draft, and American regulations at the time stipulated skin laminate thicknesses based on overall dimensions of the vessel and gave no minimum depth from which the recommendations were calculated. The hull was very stiff and the impact of waves on the hull resulted in the cracking and subsequent holing of the sandwich panel.

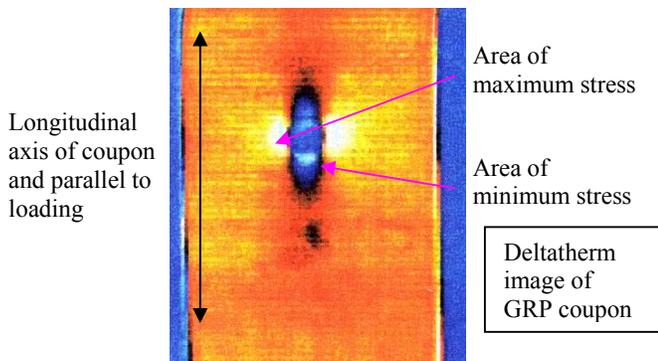
A large yacht suffered the loss of its carbon fibre mast after only a few days in service. The mast was manufactured in two U-shaped sections adhesively bonded along the neutral axis (port/starboard line). There were various apertures along the mast to allow for access to hydraulics and rigging attachment. Each opening in the mast results in a change in the local stress field and an example of the stress field surrounding an unloaded hole can be seen below. The image is a map of the stresses in a mode I cyclically loaded glass fibre coupon with a 6mm diameter through thickness hole.

Note that the stress directly above and below the hole is less than the nominal stress, however this is only a localised effect and diminishes with distance from the defect as the matrix redistributes load to fibres bisected by the hole. Effects like this are understood and can be modelled however this must be done early in the design process and details that are likely to cause stress concentrations should not be grouped together as they will have a cumulative effect in weakening the structure.
